DI-8B42-01 4-20mA Current Loop Transmitter Workaround

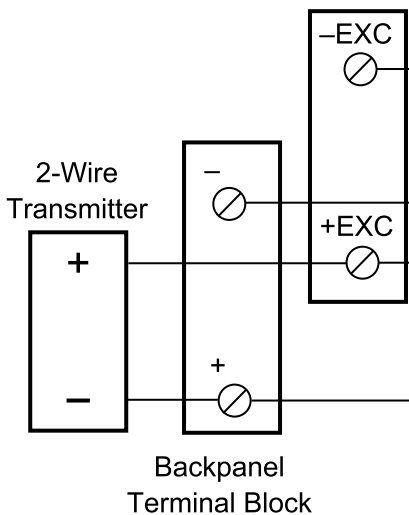
Readings in WINDAQ appear erratic when attempting to acquire data from a 2-wire transmitter using a DI-8B42-01 module.

Rarely, the DI-8B42-01 module could go into oscillation with certain transducers.

The transmitter should be connected across Ex+ and In+.
